# Dead Neck Beach Nourishment Monitoring and Data Analysis - 2010 Osterville, Massachusetts

by Sean W. Kelley, P.E.  
Robert B. Acker  
John S. Ramsey, P.E.

**FINAL REPORT – January 2011**

**Prepared for: Three Bays Preservation , Inc.  
Osterville, MA**

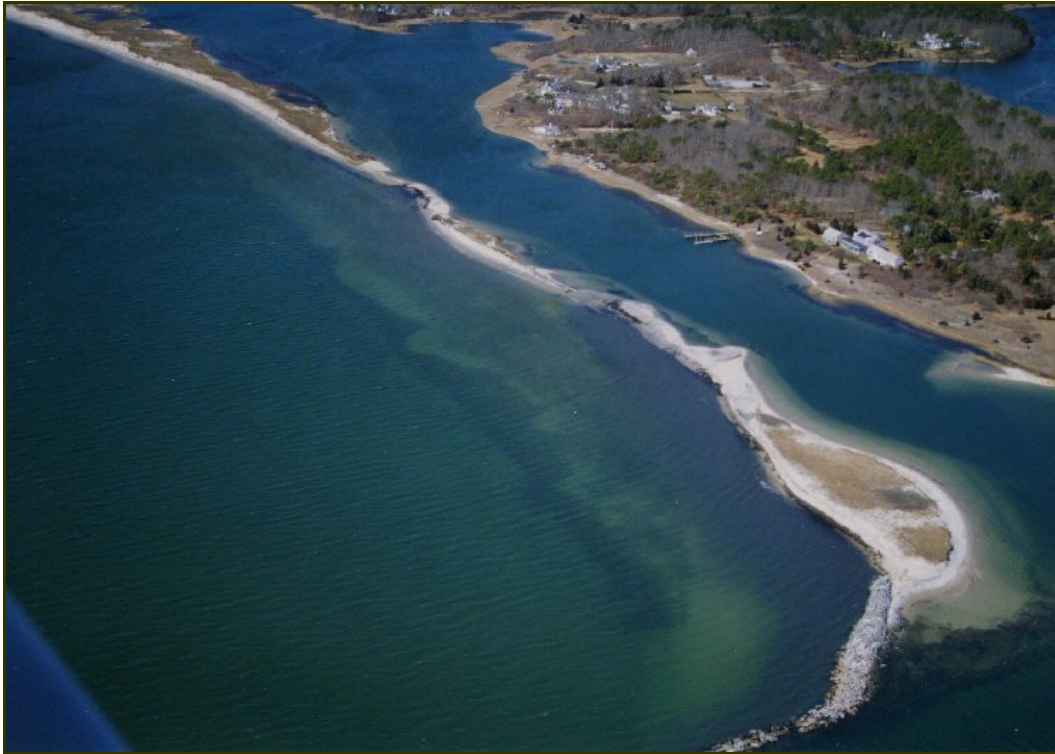
Figure 1. The eastern portion of Dead Neck in 1999, showing at least two locations where the beach had significant storm overwash areas.

resulted in an average fill volume of 95 cubic yards per foot of shoreline. In 2000, the fill was supplemented with an additional 25,100 cubic yards of sand, placed over the easternmost 1,000 feet of the island. The total volume of sand for the 1999-2000 nourishment project was therefore 212,400 cubic yards. Figures 1 and 2 show before and after views of the nourishment area.

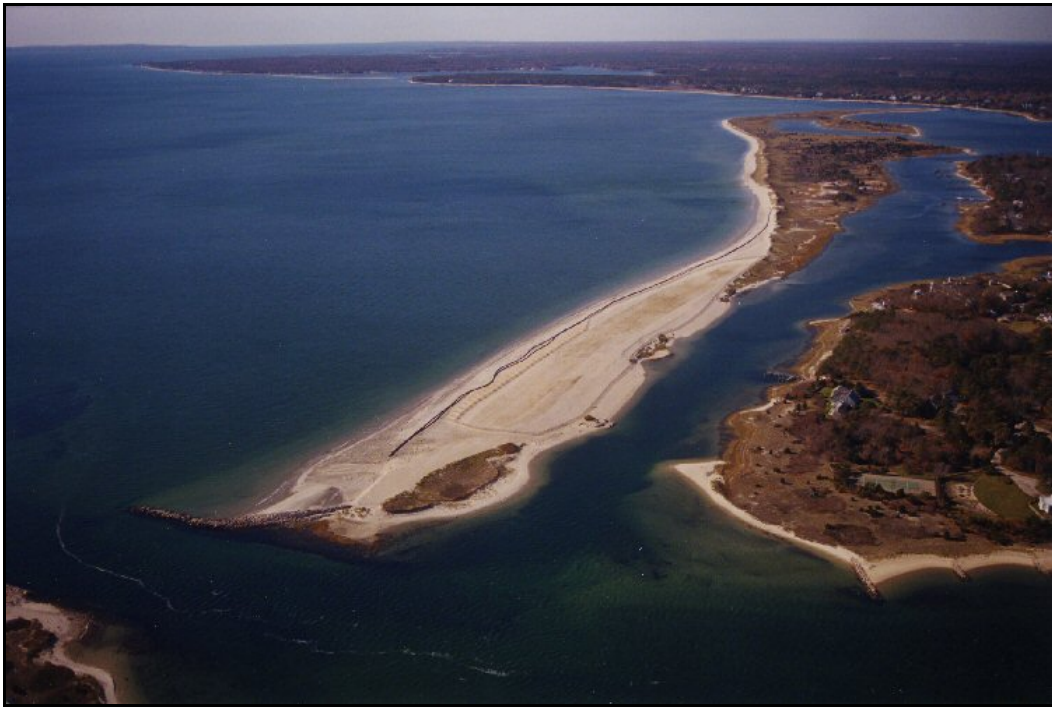
Figure 2. Dead Neck Beach immediately following the beach nourishment in 2000, where the beach width had been increased significantly to prevent breaching of the barrier.

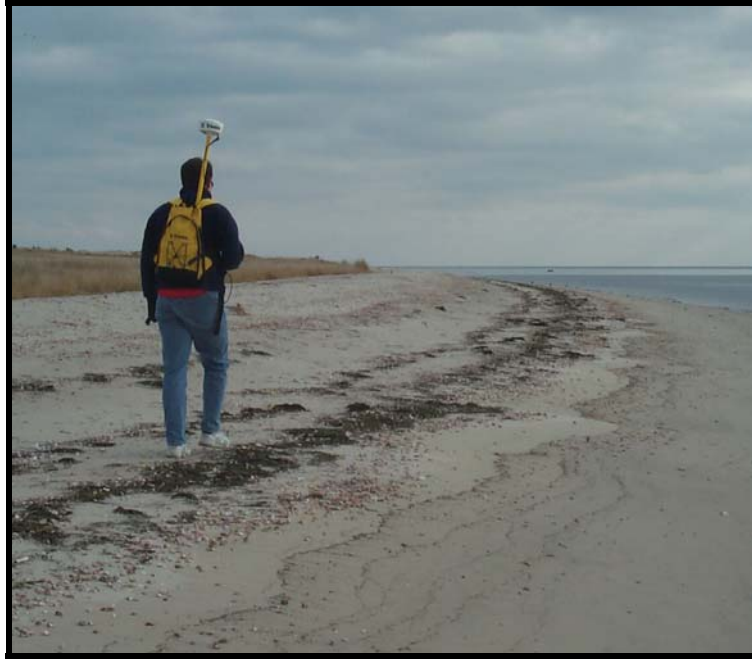
Figure 3. Collecting Dead Neck shoreline position data using a Trimble Backpack DGPS unit.

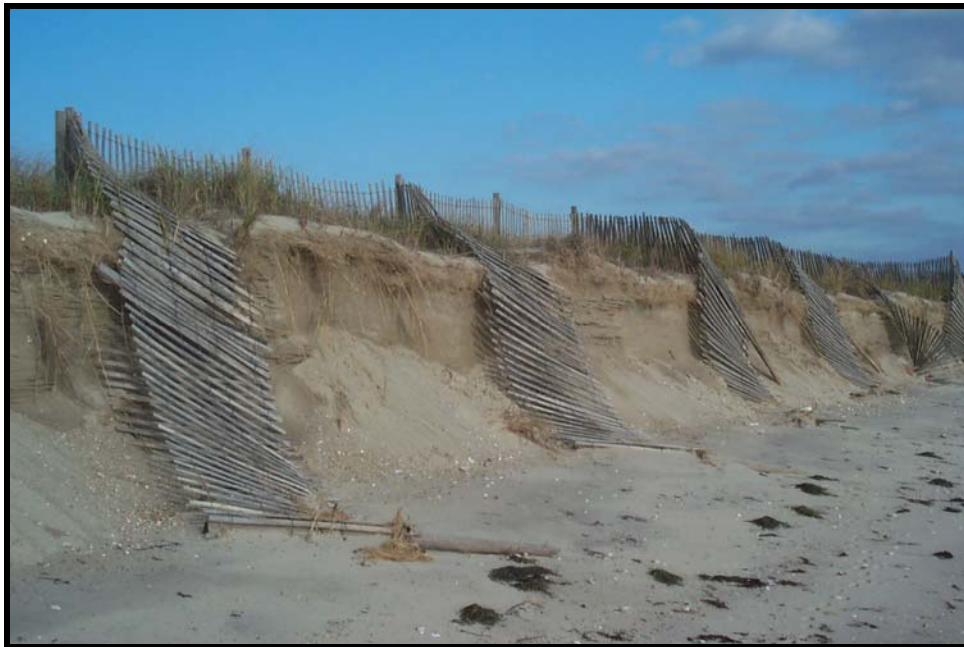
At the time of the first shoreline survey in November 2002, the filled beach profile already had eroded noticeably. This was made most evident by the steep scarp-face of the filled area and also by the failure of sections of sand fencing that had been placed on the crest of the fill at the time of the nourishment (Figure 4). By the time of the January 2006 survey, all of the sand fencing was gone, though the scarp face remained.

Figure 4. At the time of the November 2002 shoreline survey of Dead Neck, sand fencing set-up in the nourishment area had begun to fail due to erosion of the beach fill.

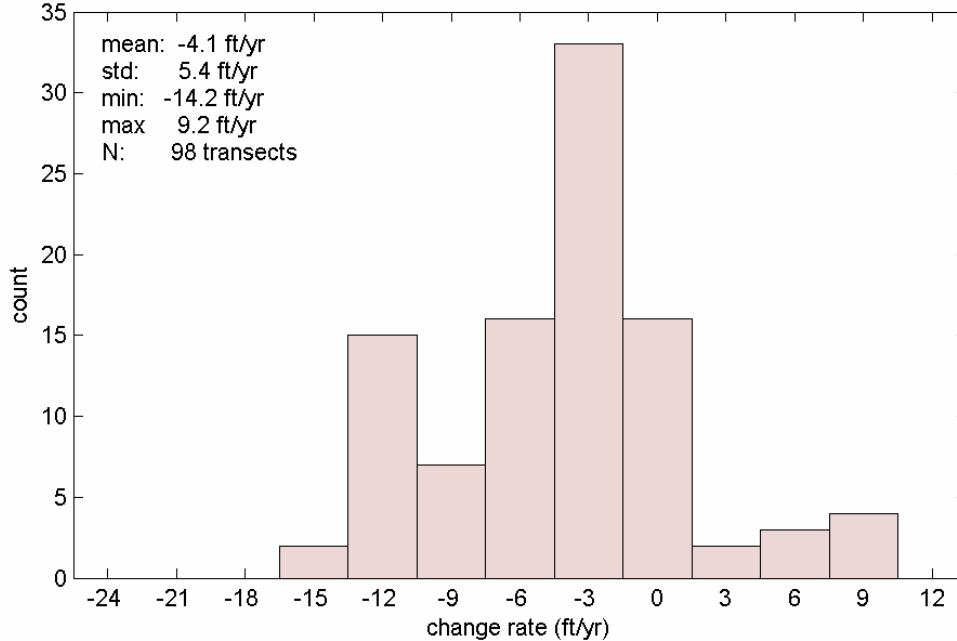
Shoreline change statistics for the entire Dead Neck shoreline are presented in Figure 10. In this figure, a histogram plot of shoreline change rates shows the frequency distribution of rates for the entire seaward shoreline. Between 2002 and 2010, the mean change rate was  $-4.1$  ft/yr, indicating that on average, the Dead Neck shoreline was erosional. These results are based on the analysis of shore-normal transects spaced between 100 feet and 200 feet along the shoreline.

Figure 10. Histogram plot of annualized shoreline change rates between 2002 and 2010 GPS shorelines. Rates were computed along the entire seaward shoreline of Dead Neck, determined using a total of 102 shoreline transects.

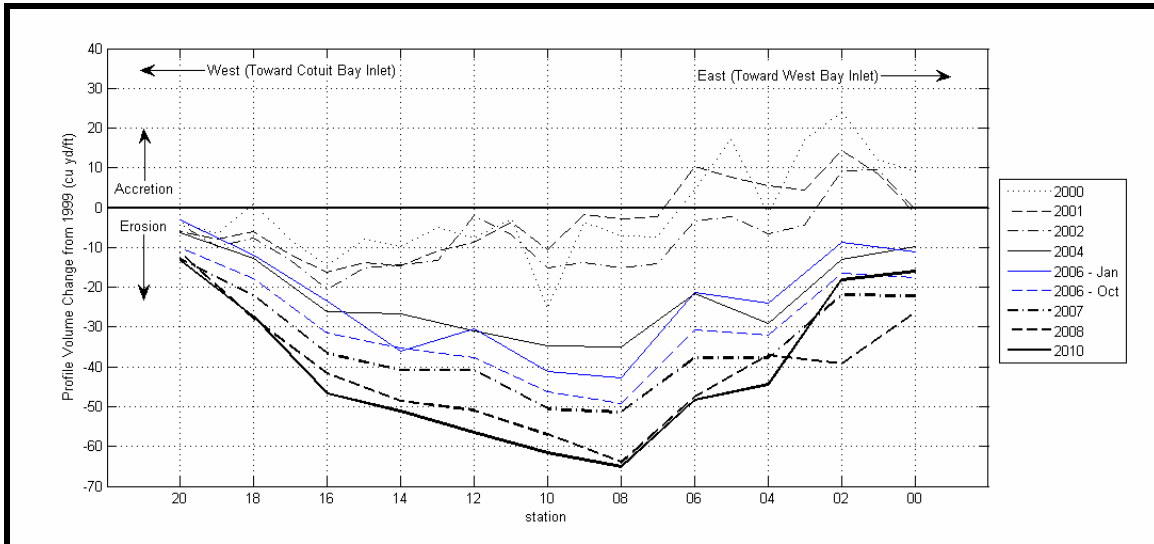
Using the available profile data, volume change rates were computed along the length of the 1999 nourishment, between stations 00+00 (at West Bay inlet) and 20+00 (2,000 feet west of West Bay inlet). The results of these computations are shown in Figure 11. In this plot, the first three survey periods indicate accretion at the east end of Dead Neck. This accretion is due to the addition of 25,100 cubic yards of dredged sand in early 2000 on the first 1,000 feet of the beach (i.e., between stations 00+00 and 10+00).

Figure 11. Profile volume loss from the 1999 measured profiles computed for each cross-shore survey transect in the nourishment area. The results from 2004 to 2010 are based on 200-ft transect spacing, while results from all other years are based on 100-ft transect spacing.

The September 2004 survey is the first time that all profiles were indicating volume loss. The trends of loss across from Stations 0+00 to 20+00 are similar over the past 3 years. The greatest volume loss had occurred in the reach between Station 08+00 to Station 10+00, where more than 50 cubic yards per foot length of beach ( $\text{yd}^3/\text{ft}$ ) of fill material have been lost from the profile. Volume losses are smaller at both ends of the nourishment. At the west end of the nourishment, losses are likely mitigated due to the availability of sand from the updrift (eastern) portion of the nourishment area. At the eastern end, volume losses only appear to be less than toward the center of the nourishment, again due to the additional 25,100  $\text{yd}^3$  of sand placed on this end of the beach in early 2000. The recent accretion from Stations 0+00 to 0+03 is due to a nourishment event in January 2009 of approximately 12,000  $\text{yd}^3$ .

The largest volume loss continues to be in the center of the 1999 nourishment (Stations 06+00 to 15+00) with the greatest losses occurring again in the area of Station 08+00. The eastern (Stations 0+00 to 4+00) and western (Stations 16+00 to 20+00) ends of the survey show minor losses when compared to 2007, while the more significant volume loss occurs in the center of the area. The eastern section of the 2010 survey (Stations 0+00 to 6+00) shows the largest change from the 2008 Survey due to the nourishment event mentioned above. The volume loss in the central and western reaches is smaller, with some areas showing near-stability.

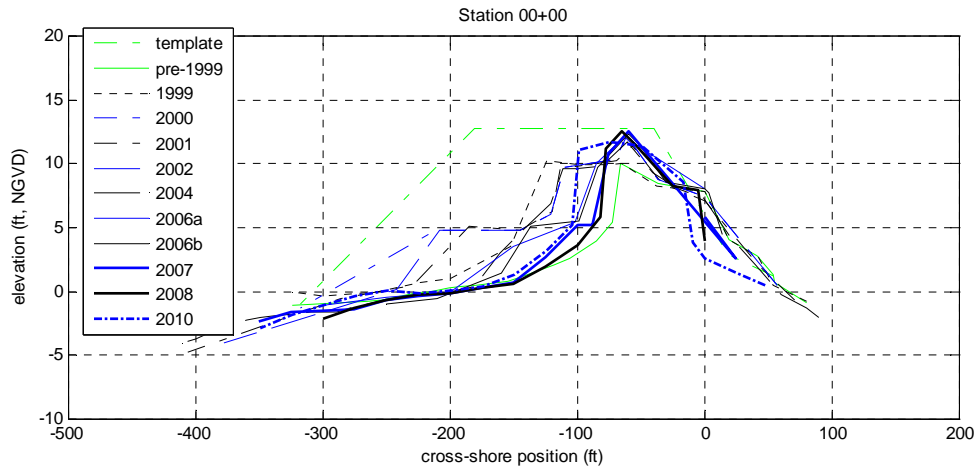
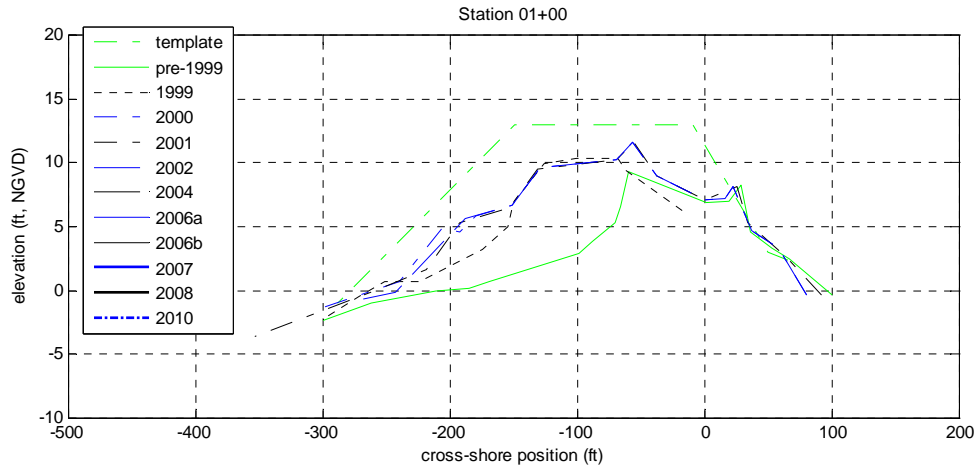
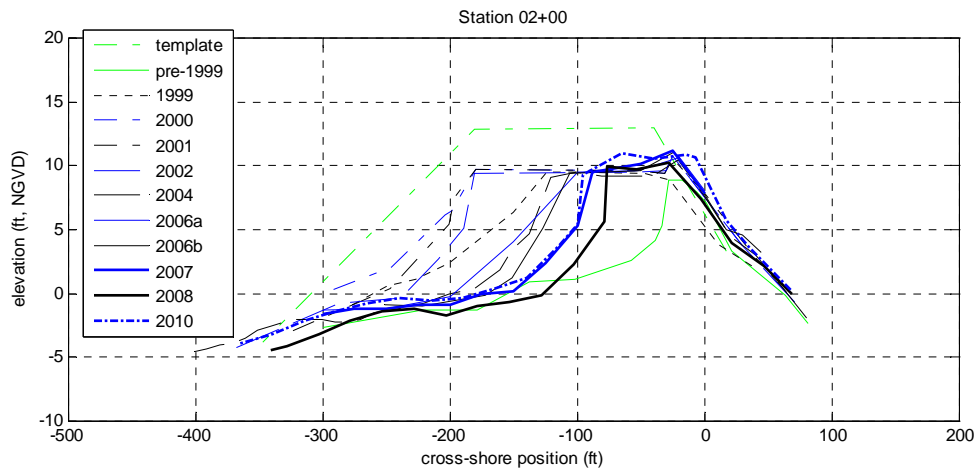
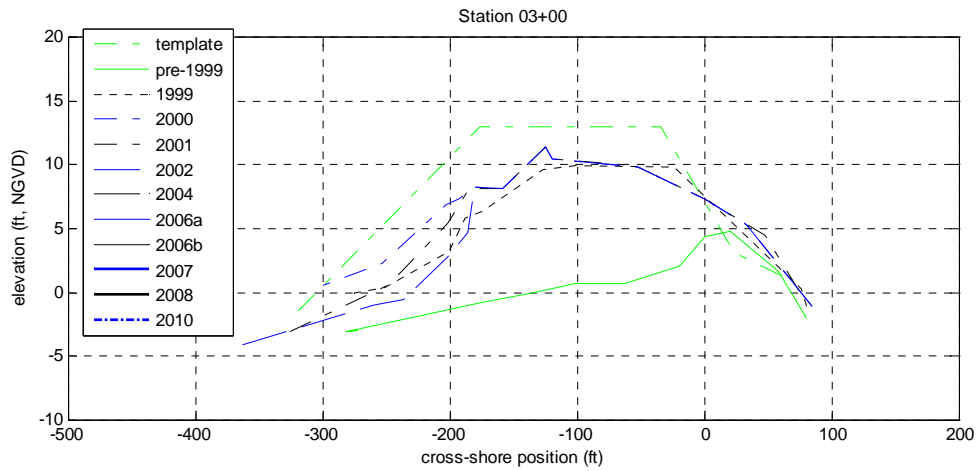
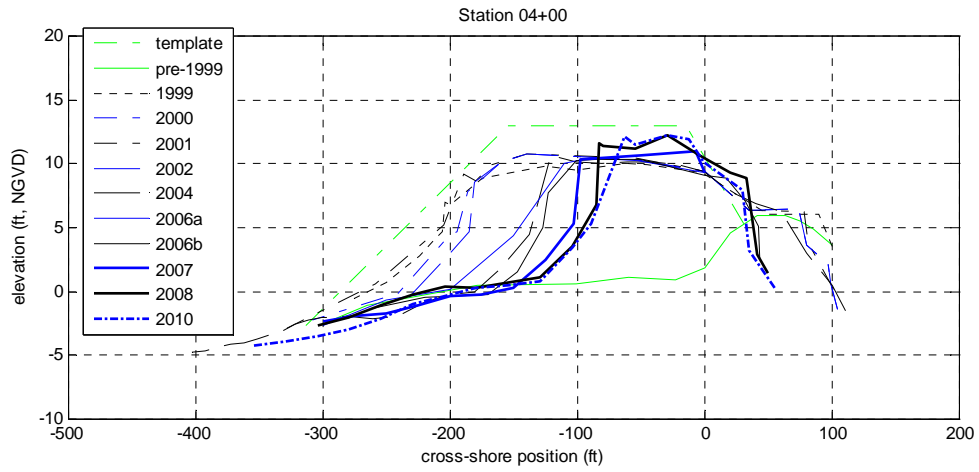
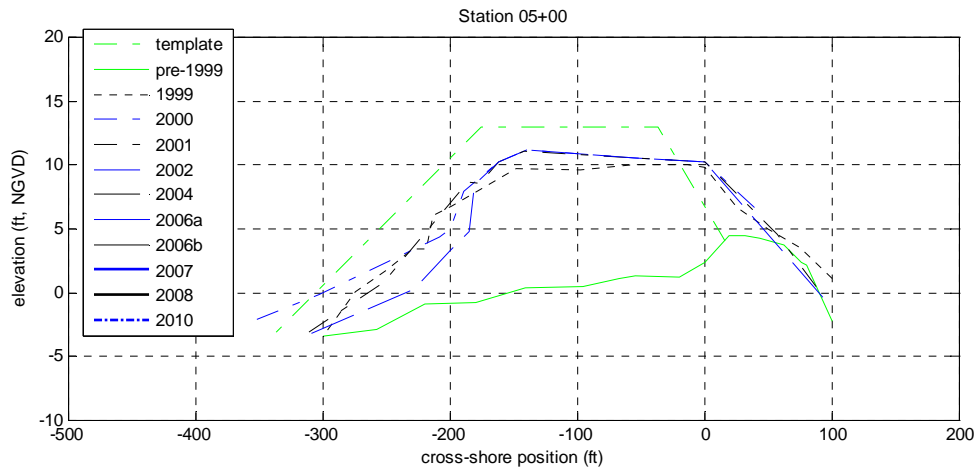
## **Appendix: Cross Shore Profile Plots**

Plots of the profile data from the data listed in Table 1 are presented in the Appendix of this report. The construction template, pre-nourishment template and March 1999 survey profile data were digitized from plans created by GBA (1999). All other profile data sets were available in processed tabular formats.
