THE MASSACHUSETTS ESTUARIES PROJECT

BACTERIA TMDL FOR MUDDY CREEK

Draft Report # MA96-51-2004-01

Chatham & Harwich Massachusetts Cape Cod Watershed

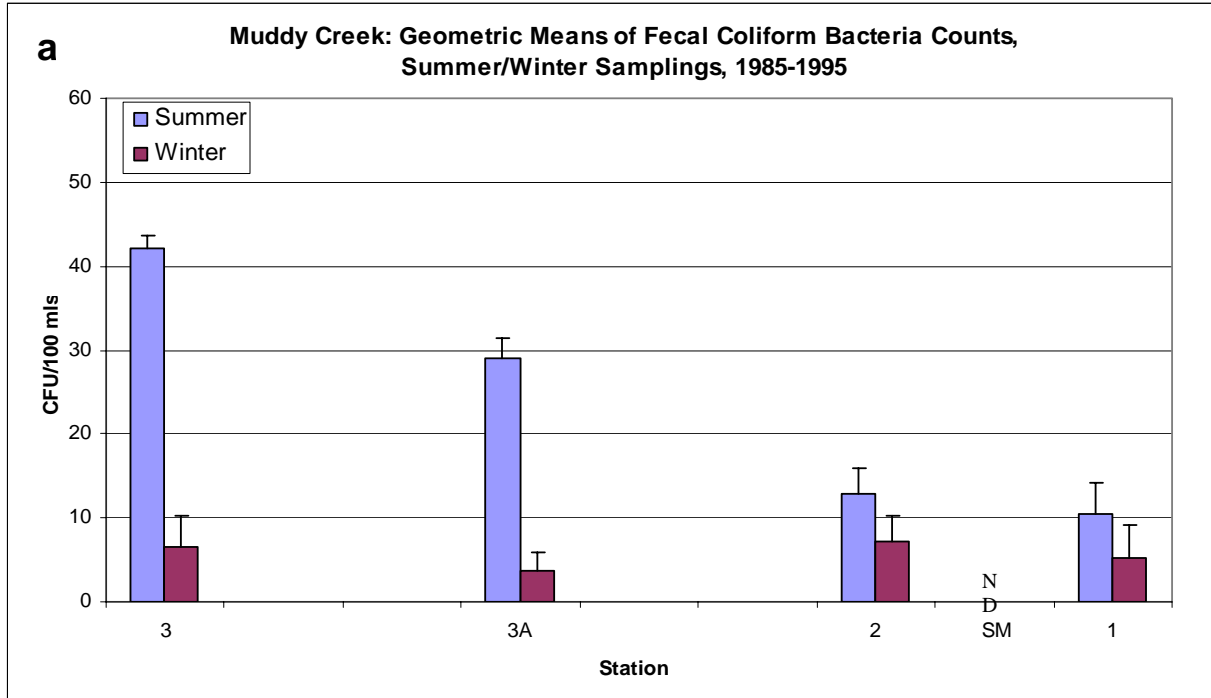
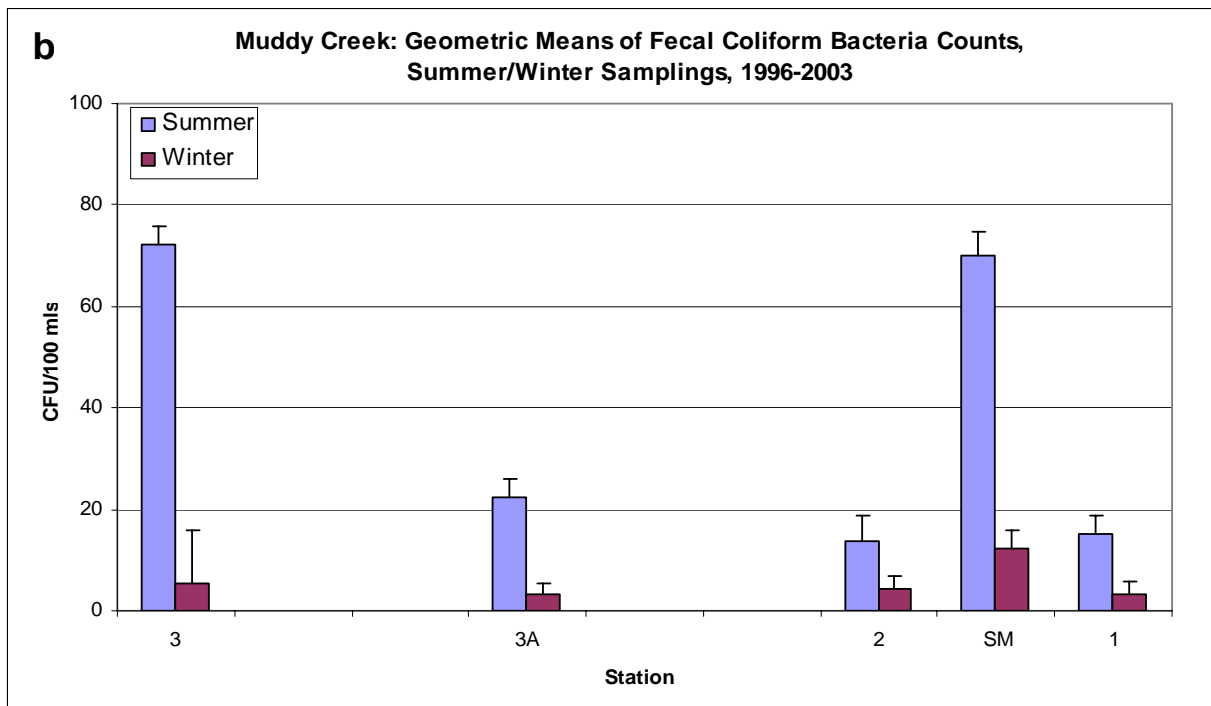
Figure V-4 Summer and winter Fecal Coliform bacteria counts (CFU/100 mls) during the years (a) 1985-1995 and (b) 1996-2003.

Numbers indicate geometric means for summer/winter samplings by Massachusetts Division of Marine Fisheries, Town of Chatham Water Quality Department and SMAST (SM).

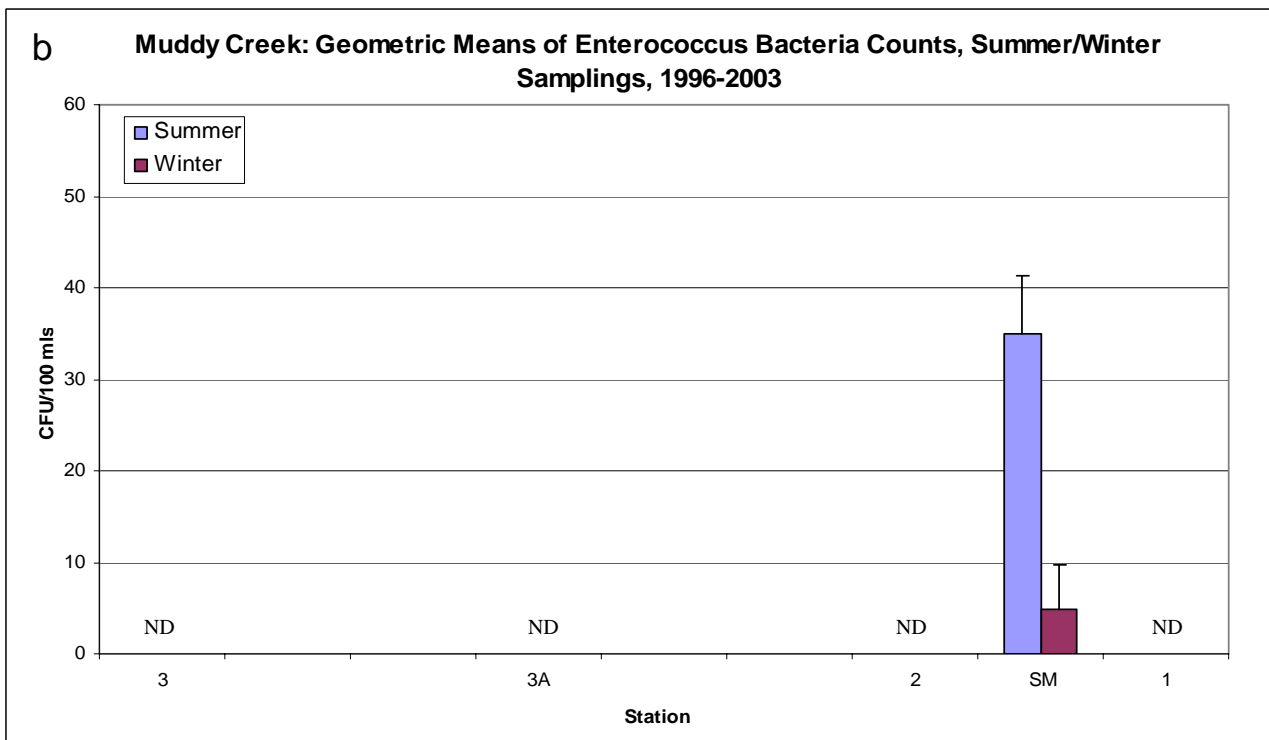
Figure V-5 Summer and winter *E. coli* (a) and *Enterococcus* (b) bacteria counts (CFU/100 mls) during the years 1996-2003.

For E. coli, there were 4 wet and 10 dry samples in the summer, and 13 wet and 5 dry samples from the winter at Station SM. The summer wet weather geometric mean was 159 CFU/100 mL, while the dry mean was 56 CFU/100 mL. Both means exceeded the water quality standard of 43 CFU/100 mL and more than 10% of the samples exceeded the water quality standard of 43 CFU/100 mL (Table V-3b). The wet mean to dry mean ratio was 2.8, indicating that *wet inputs were approximately 3 times higher than dry inputs in the summer*. The winter wet and dry geometric means at Station SM were 7 CFU/100 mL. Neither exceeded the water quality standard and only the wet samples had more than 10% above the water quality standard of 43 CFU/100 mL. *The wet mean to dry mean ratio at SM for the winter was 1.0, indicating that wet and dry inputs were equivalent* (Table V-3b).

For *Enterococcus*, there were 4 wet and 10 dry samples in the summer and 4 wet and 5 dry samples in the winter. The summer wet mean at Station SM was 119 colonies/100 mL and the dry mean was 51 colonies/100 mL for a wet mean to dry mean ratio of 2.3, *indicating that wet inputs were approximately 2-3 times greater than dry inputs in the summer and both weather conditions exceeded the water quality standard of 35 colonies/100 mL*. Seventy-five per cent of the wet samples in the summer and 40% of the dry samples exceeded the water quality standard of 104 (Table V-3c). The winter wet mean was 8 colonies/100 mL and the dry mean was 12 for a wet mean to dry mean ratio of 0.7, indicating that wet inputs in the winter were slightly less than dry inputs (Table V-3c). Neither mean exceeded the water quality standard of 35 and 8% of the wet samples exceeded the water quality standard of 104 colonies/100 mL.

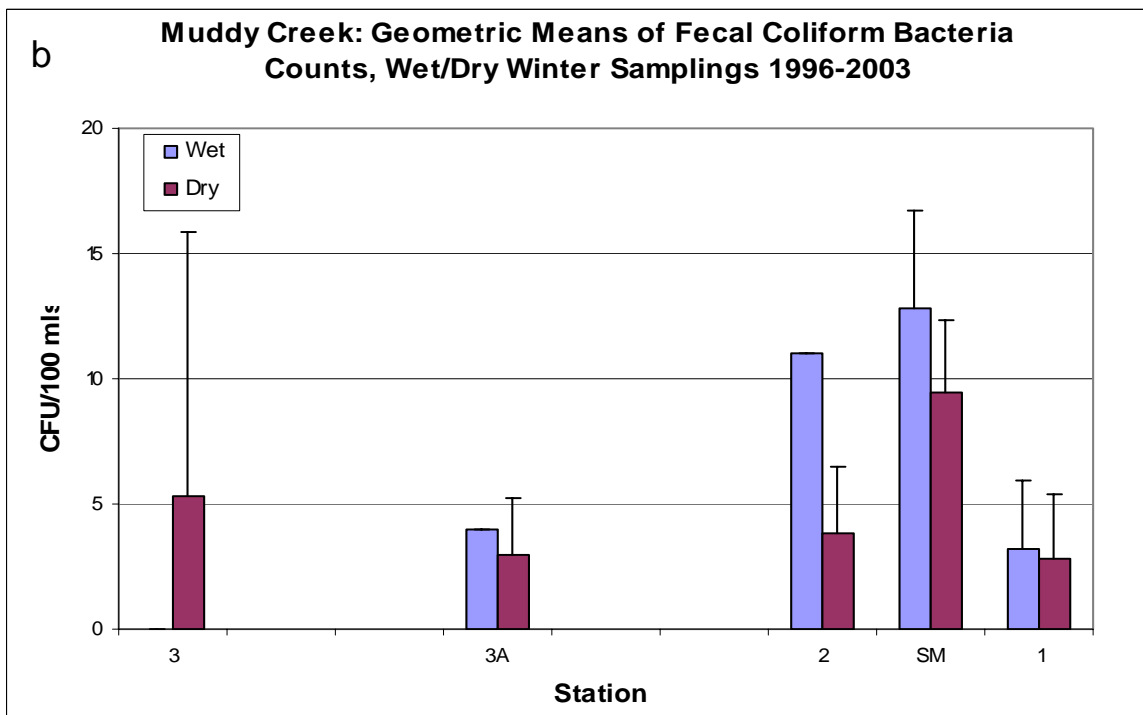
Figure V-6 Summer (a) and Winter (b) wet and dry weather fecal coliform bacteria counts (CFU/100 mls) during the years 1996-2003.
